Edgehills Quarry SSSI Management Plan: 2022 - 2032

Edgehills Quarry SSSI Management Plan

Appendix E: Natural England, Edgehills Quarry, Gloucestershire. Site visit - 09.11.2021

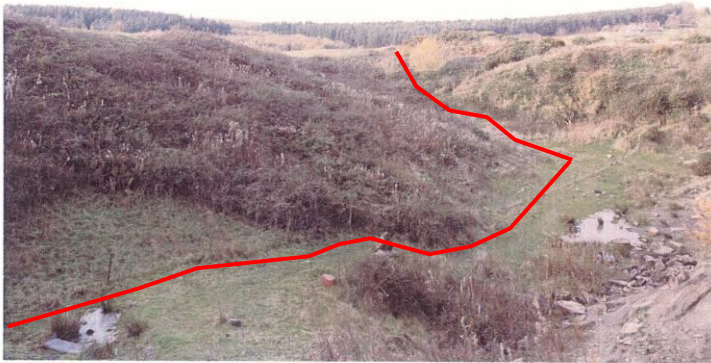
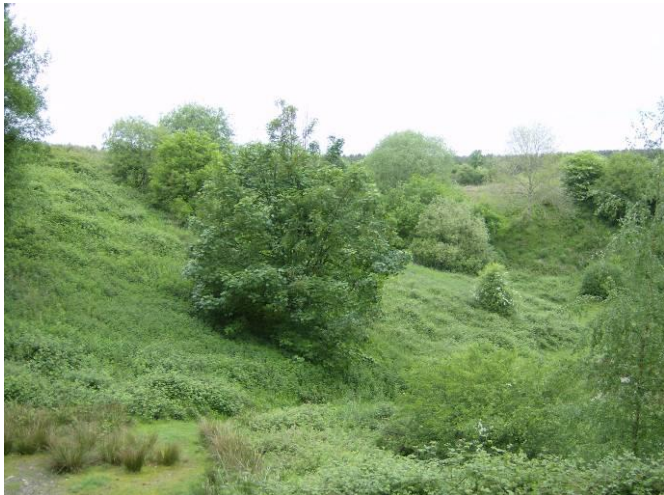
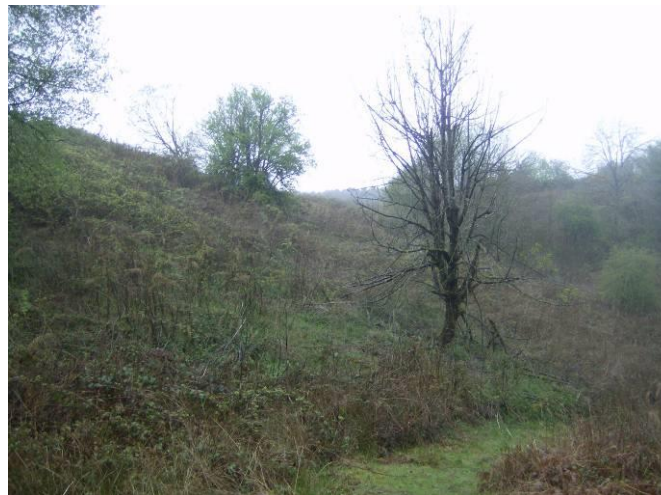
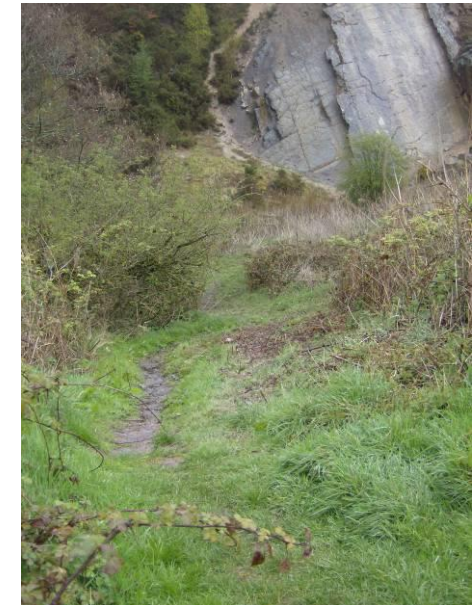
LOCATION 1 – WEST SIDE OF QUARRY

PHOTO 3. THE DEGRADED AND VEGETATED WESTERN SIDE OF THE OLD QUARRY. ORIGINALLY INCLUDED WITHIN THE GCR SITE BUT EXCLUDED FROM THE SSSI.

The western side of the old quarry opposite the exposures has changed little, with some bramble and scrub growth. This area is not part of the SSSI but does give access to the site. Access to the site is shown by the red line on the 1992 photo.

- ✓ Access has been kept open by heavily strimming vegetation from the top of the western slope down to the quarry floor and southward along the path to maintain access.

- ✓ Maintain pedestrian access to quarry floor and south along footpath
- ✓ Erect fencing along quarry floor to deter access to quarry face by climbers, along with some signage explaining why no climbing is allowed.

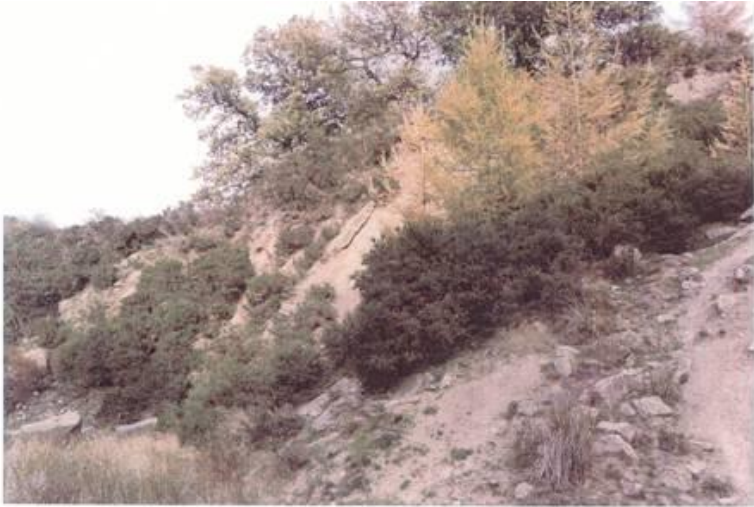
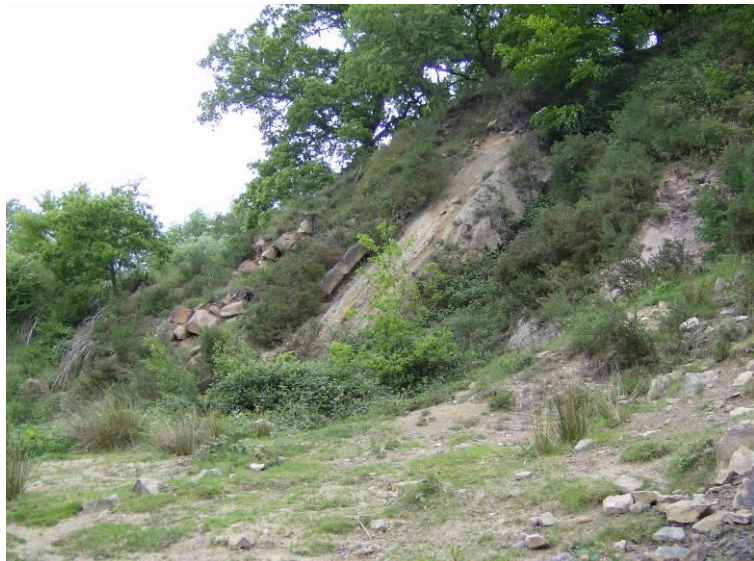
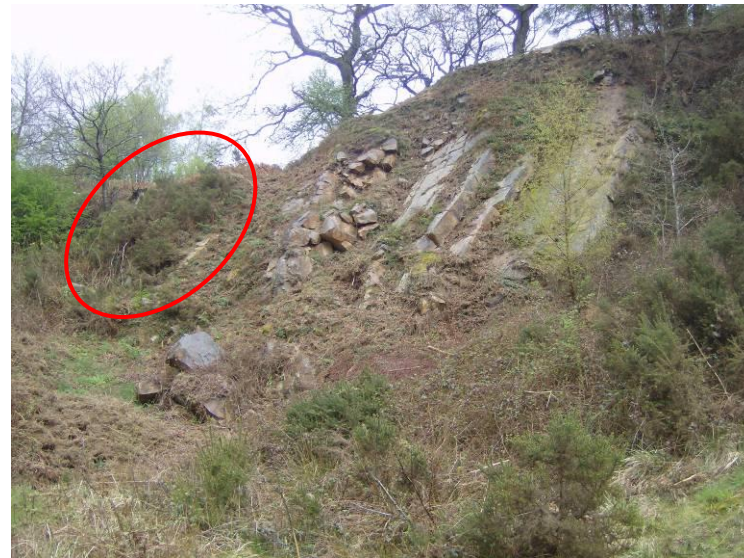
LOCATION 2 – NORTHERN END OF QUARRY

PHOTO 4. NORTHERN END OF THE QUARRY. EXPOSURE IS RATHER LIMITED HERE DUE TO COVER OF THE ROCKS BY GORSE, BRAMBLES AND YOUNG LARCH TREES.

This sequence of photos shows the rock exposures in the north easterly corner of the quarry. In 2004 some scrub clearance was carried out to improve visibility. A second treatment with Round-Up may be required in spring 2012.

- ✓ Substantial clearance of gorse and invading scrub.
- ✓ Chemical treatment of stumps to prevent regrowth.

- ✓ Respray any regrowth as required to maintain exposures
- ✓ Further clearance of Gorse if required

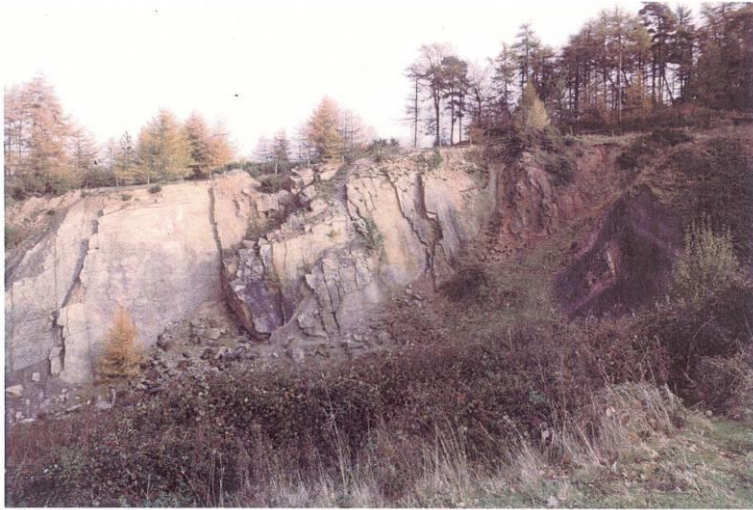
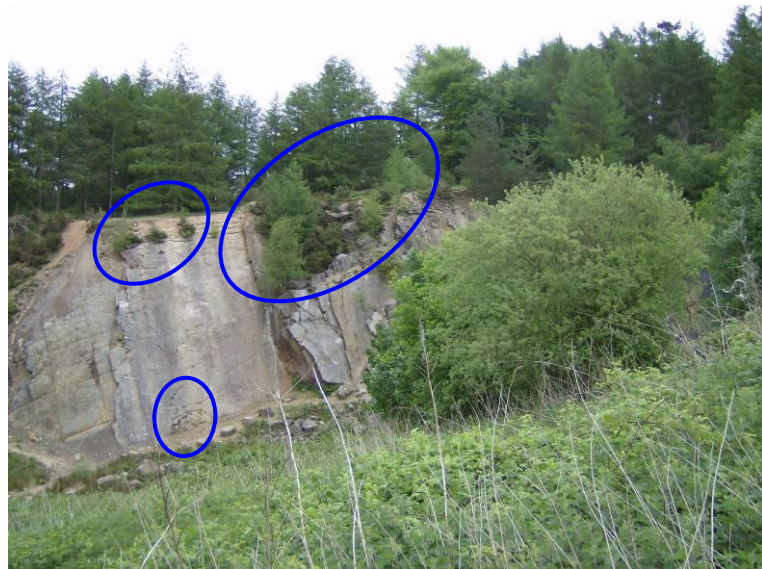
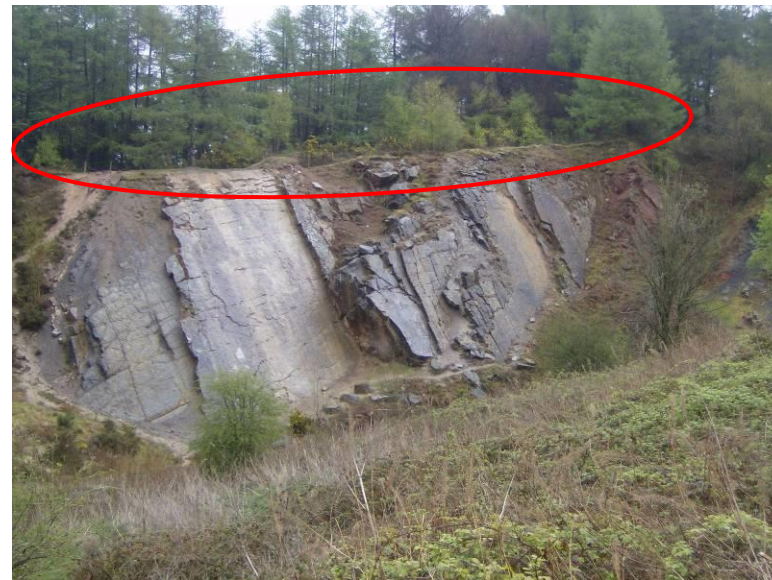
LOCATION 3 – GENERAL VIEW OF MAIN FACE

PHOTO 1. GENERAL VIEW OF EDGEHILLS QUARRY FROM THE SOUTH-WESTERN EDGE OF THE OLD QUARRY.

This sequence of photos shows management of scrub on the central and southern flanks of the quarry to maintain the exposures in favourable condition.

- ✓ Clearance of scrub on face of exposure (Nov 2011)
- ✓ Chemical treatment of stumps preventing regrowth

- ✓ Respray any regrowth as required to maintain exposures
- ✓ Remove metal belay peg at the top of the main face towards the northern end.
- ✓ Removal of tree growth along top of exposures that is being used for belaying by climbers

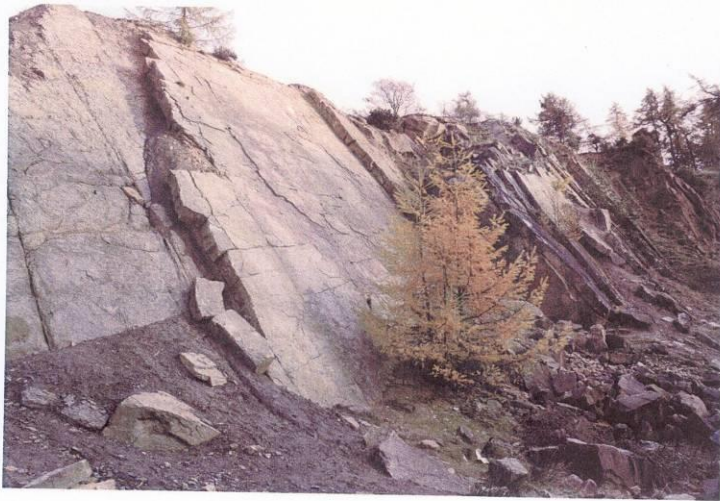
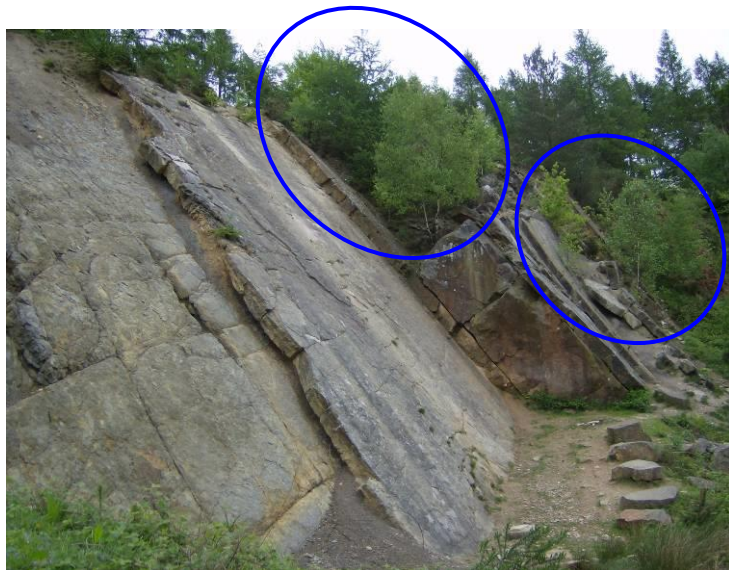
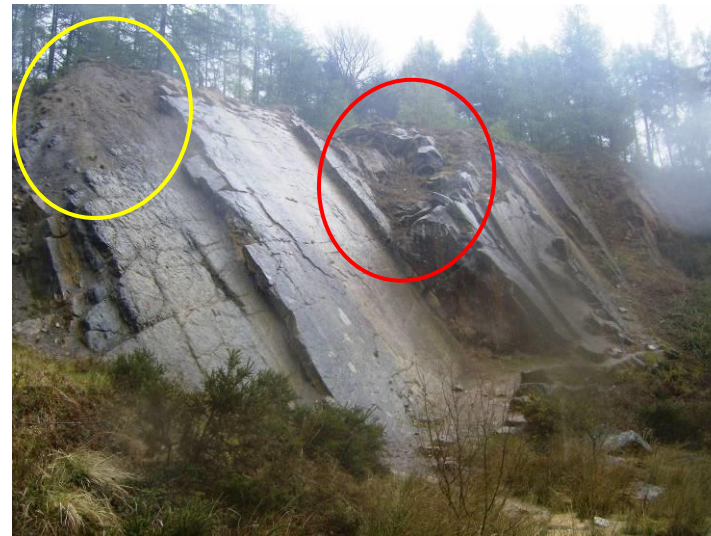
LOCATION 3.01 - GENERAL VIEW OF MAIN FACE - EASTERN QUARRY FACE

Little change to the steeply dipping bedding planes, but note that parts of the eastern face are fragmenting and loosening, also note the degrading of the rock face ringed in yellow.

PHOTO 5. EASTERN QUARRY FACE. WELL EXPOSED STEEPLY DIPPING BEDDING PLANES OF THE DRYBROOK SANDSTONE.

- ✓ Monitor vegetation growth cut and respray if required.

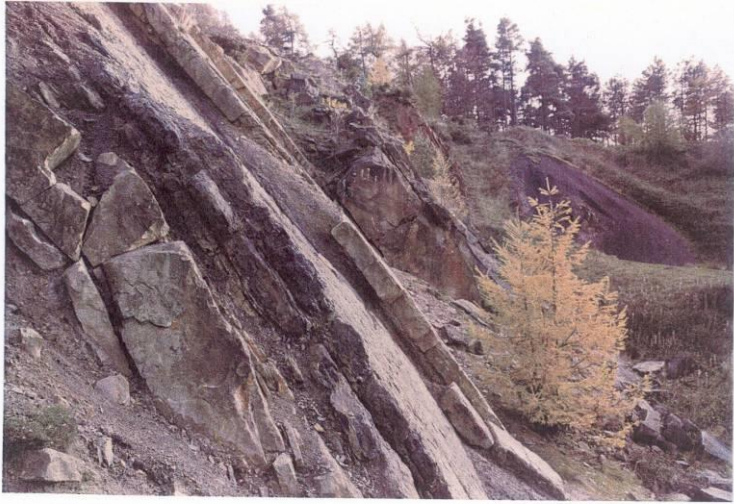
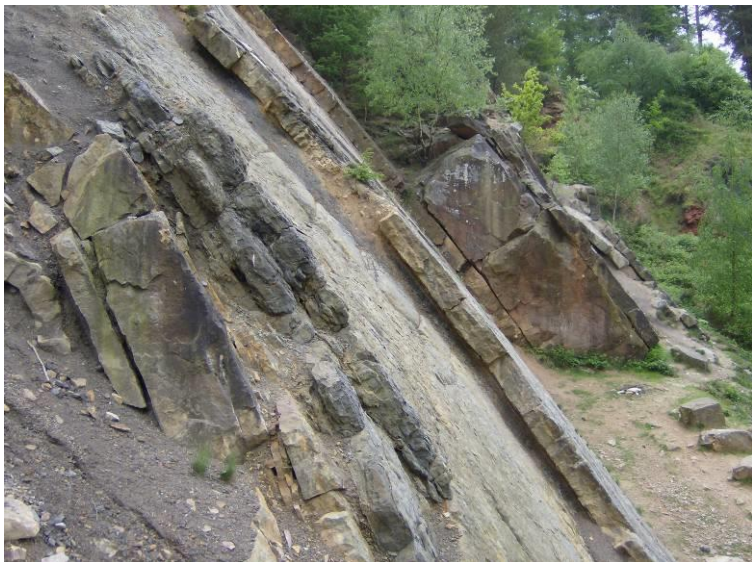
LOCATION 3.02 - GENERAL VIEW OF MAIN FACE - EASTERN QUARRY FACE

PHOTO 6. CROSS-SECTIONAL VIEW OF SANDSTONE AND SHALE SEQUENCE IN THE DRYBROOK SANDSTONE, CENTRAL EASTERN FACE.

Sandstone and shale sequence still well exposed.

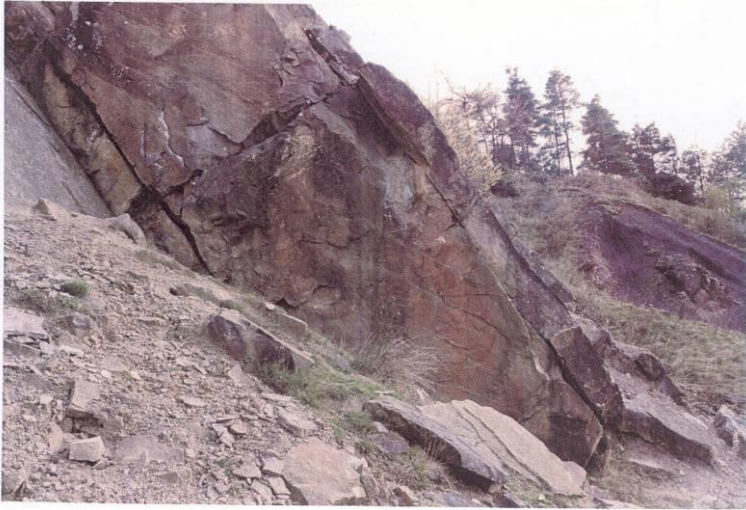
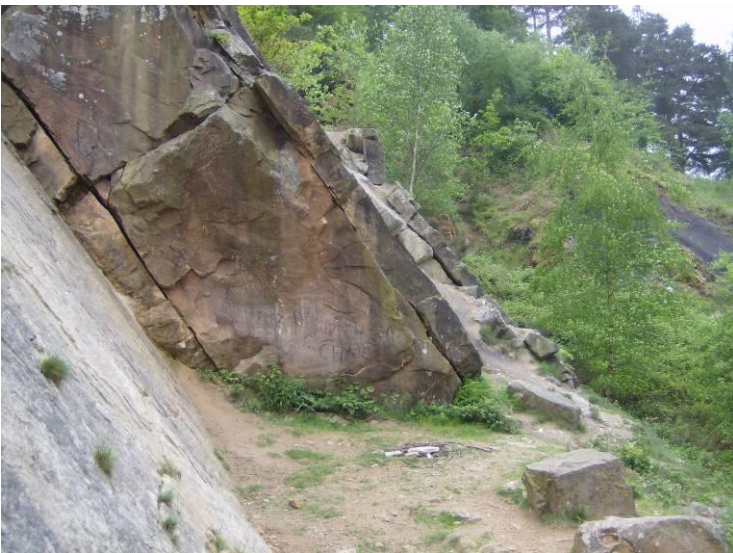
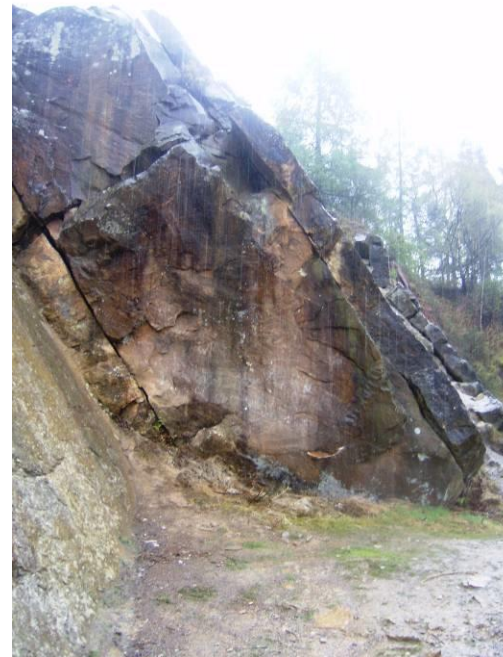
**LOCATION 3.03 - GENERAL VIEW OF MAIN FACE
- EASTERN QUARRY FACE**

Massive sandstone bed at southern end of main face.

PHOTO B. MASSIVE SANDSTONE BED EXPOSED TOWARDS THE SOUTHERN END OF THE QUARRY.

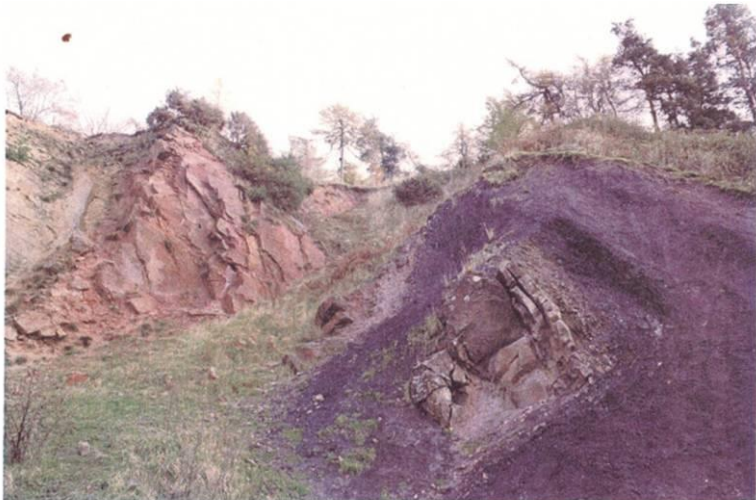
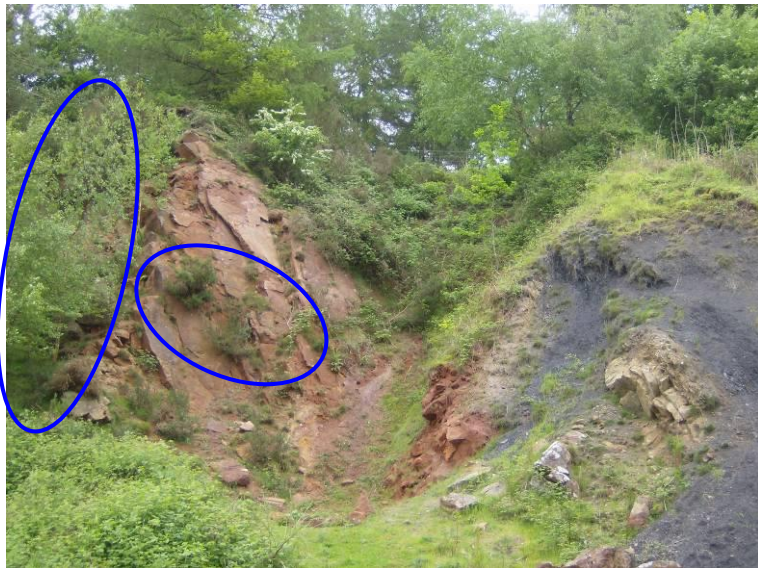
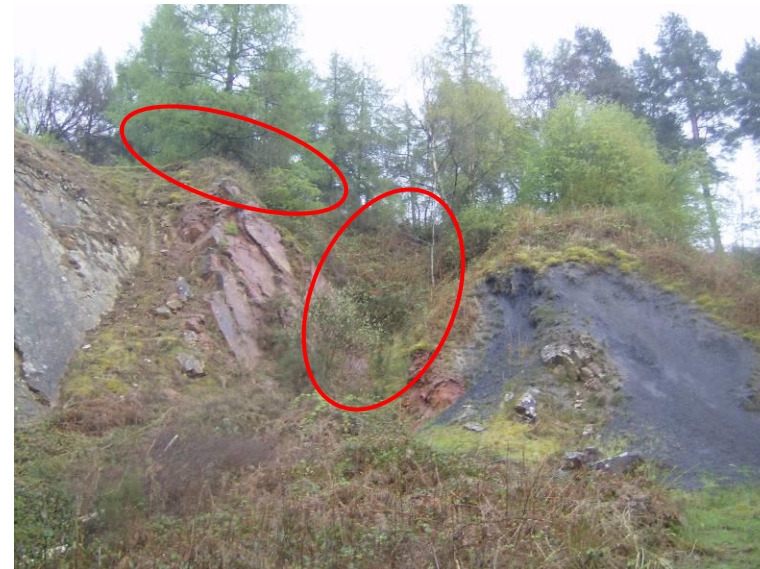
LOCATION 4 – SOUTHERN END OF QUARRY

PHOTO 9. GENERAL VIEW OF THE SOUTHERN END OF THE QUARRY THE MAIN EXPOSURE OF THE EDGEHILLS SANDSTONE. THIS COMPRISES A SANDSTONE CARBONACEOUS MUDSTONES AND A THIN SOOTY COAL.

Sequence of photos illustrating vegetation development in the south Eastern corner of the quarry.

- ✓ Clearance of scrub on face of exposure
- ✓ Chemical treatment of stumps preventing regrowth

- ✓ Further scrub clearance between the coal and the sandstone exposures to be agreed with Natural England.
- ✓ Scrub clearance along the top of the exposure to be agreed with Natural England.
- ✓ Chemical stump treatment preventing regrowth.

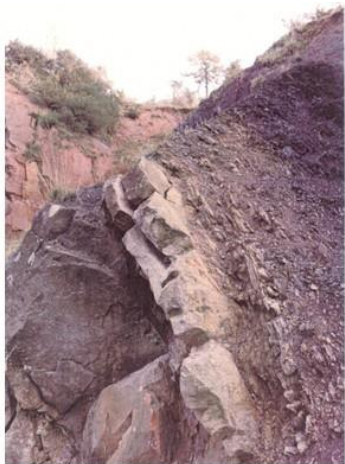
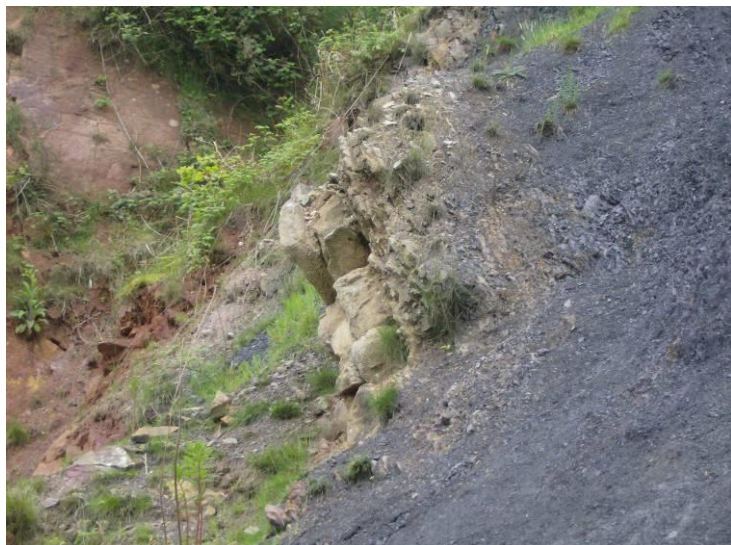
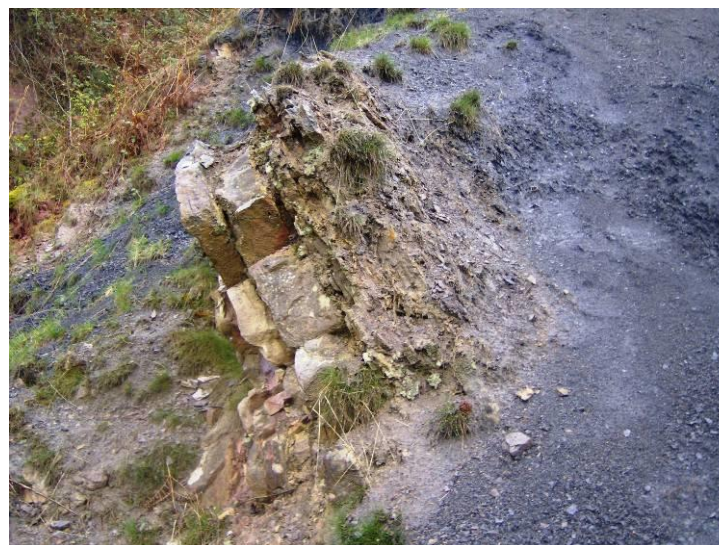
LOCATION 5 – SOUTH EASTERN CORNER

PHOTO 10. DETAIL OF THE EDGEHILLS SANDSTONE AT THE SOUTHERN END OF THE QUARRY. THIS HORIZON HAS YIELDED IMPORTANT PLANT MACROFOSSILS COMPARABLE WITH THE FLORA AT THE PUDDLEBROOK QUARRY.

The sandstone, carbonaceous mudstones and thin layer sooty coal is still well exposed. Some grass is beginning to appear in patchy clumps.

- ✓ Monitor grass growth to ensure visibility of exposure is not compromised.
- ✓ Consult with NE over best method of control.

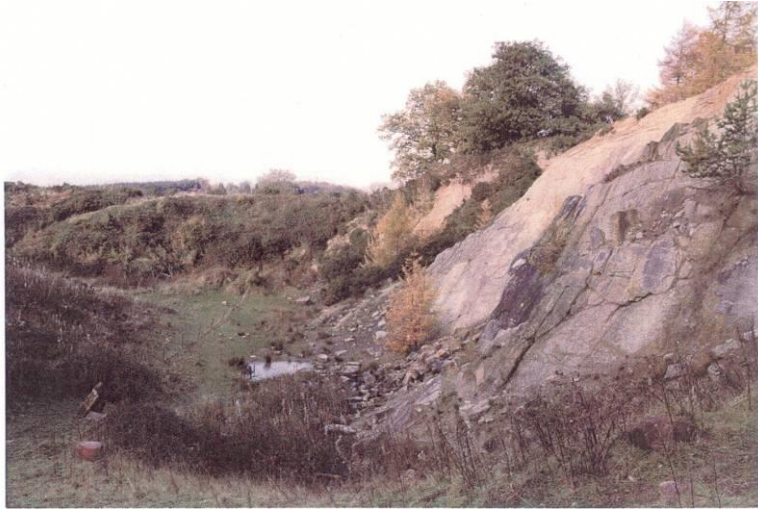
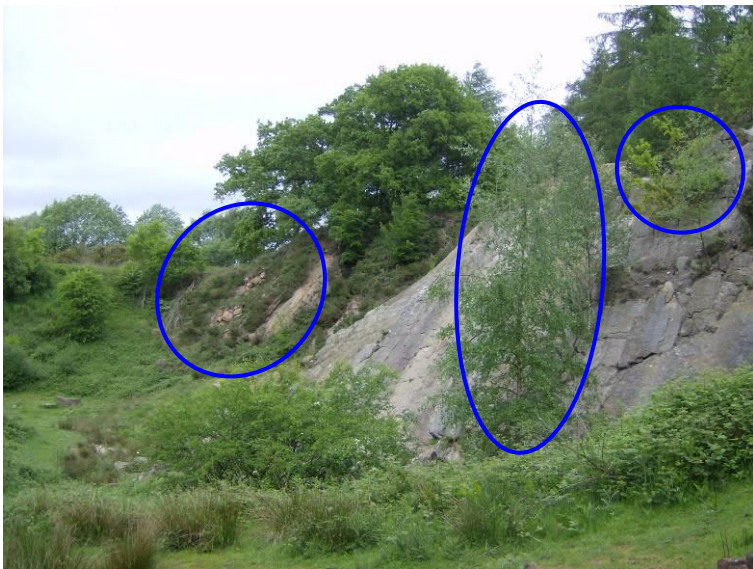
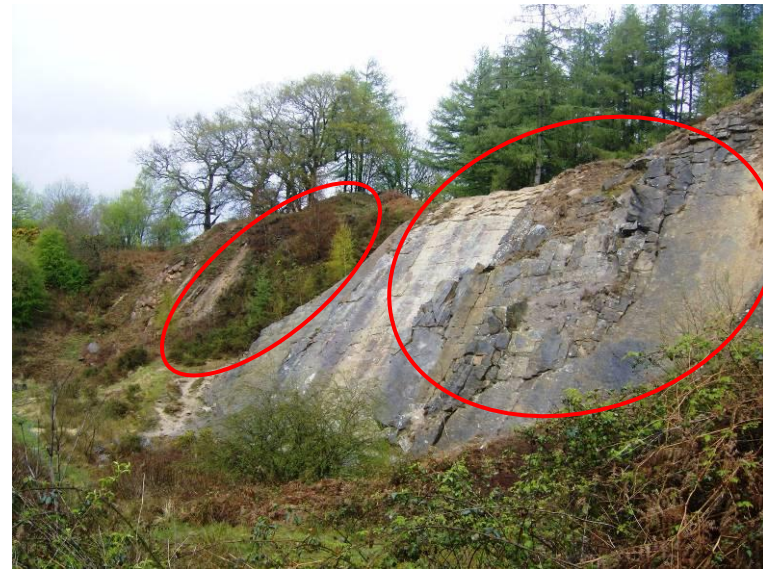
LOCATION 6 – GENERAL VIEW FROM SOUTHERN END

General condition of quarry is good. Vegetation on floor of quarry is more bramble than in 1992 when grass was prevalent.

PHOTO 2. GENERAL VIEW OF THE SITE FROM THE SOUTHERN END OF THE QUARRY. THE SITE BOUNDARY FOLLOWS THE FENCE RUNNING ACROSS THE FLOOR OF THE QUARRY AND THE TOP OF THE QUARRY EDGE ITSELF.

- ✓ General scrub clearance from quarry faces and floor of quarry
- ✓ Chemical treatment of stumps to prevent regrowth

- ✓ Consult with Natural England over further scrub clearance between the main central face and northern end of quarry.
- ✓ Monitor vegetation growth and treat if required

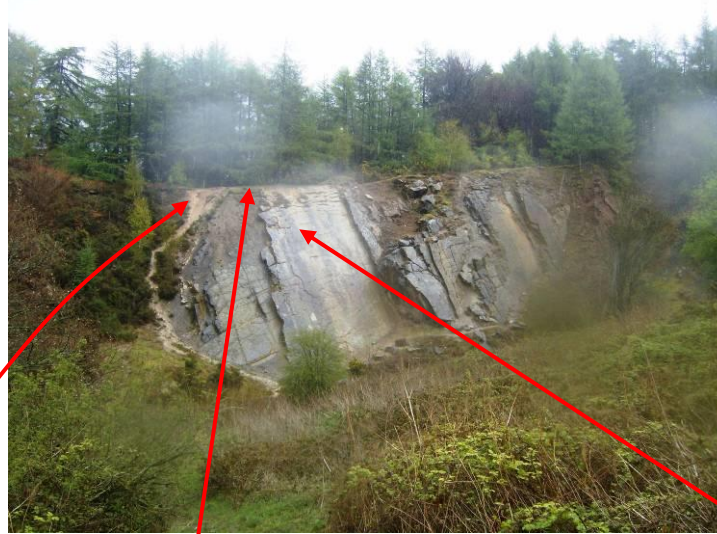
EROSION

Northern end of the central main face:
A path coming down the north side of the main face from the top of the quarry. The main photo and below left shows erosion caused by climbers, and now channelling rain water

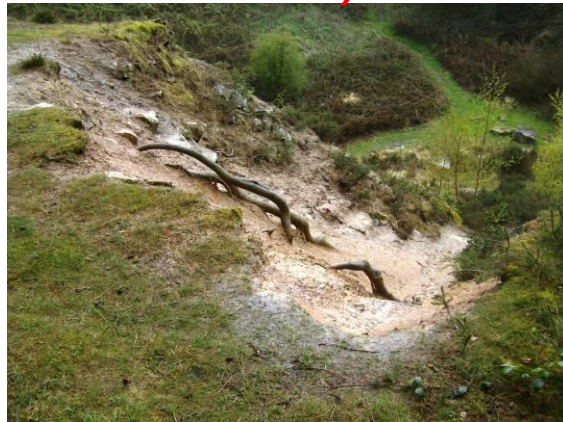
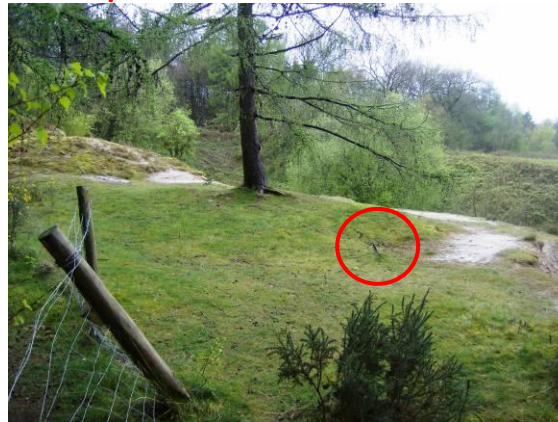
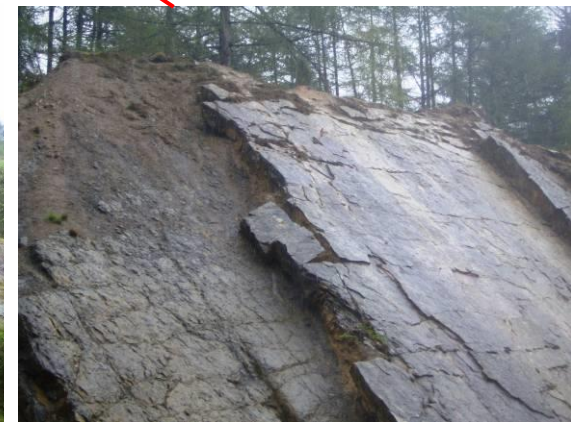
STABILITY

The quarry is detailed in one of the local climbing guides and sees a fair amount of use; since 2007 use by climbers seems to of increased. The photo below shows erosion along the top edge of the main quarry face and also the loosening and fragmenting of blocks, although this is probably mainly due to physical agents such as rain frost and ice; is not helped by the climbers.

The middle photo shows a well worn path along the top edge of the quarry, used by climbers. Ringed in red is an iron bar used by the climbers as a belay point, as is the larch tree. The safety fencing seen in the photo is in need of renewal; this is mandatory for health and safety management and will hopefully deter climbers. Some signage explaining the site located here may also help.

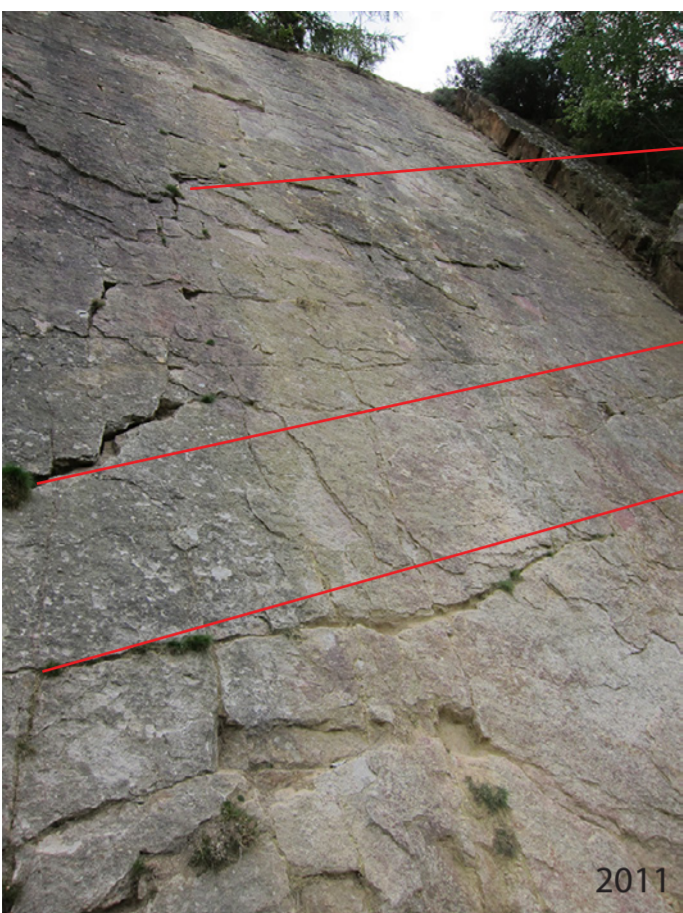
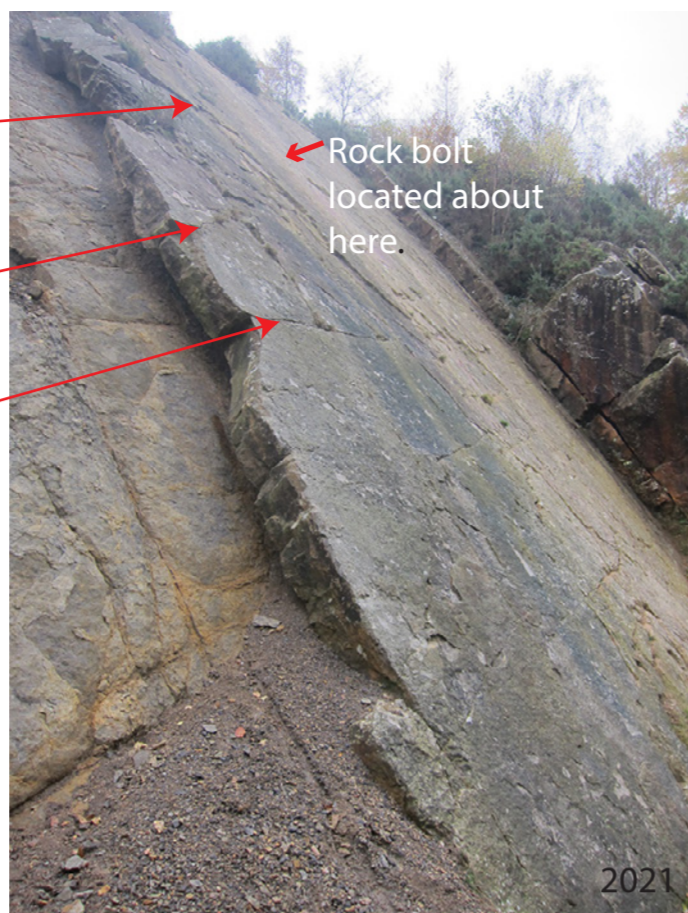
Face in hard sandstone showing ripple marks on surface. Images suggest very little overall change in the intervening ten years, although the ripple marks are less clear in this image. This is likely to be because of the lighting angle. The 2011 image was taken in August when the sun was stronger and higher.

There is single bolt in this face. It is not clear how long it has been there. Installation of bolts on this face damages the interest features, and their removal could cause even more severe damage. There may be some rope-wear at the top of the face, but this was not inspected closely as it was inaccessible, and in this case, will not be causing damage to the interest features.

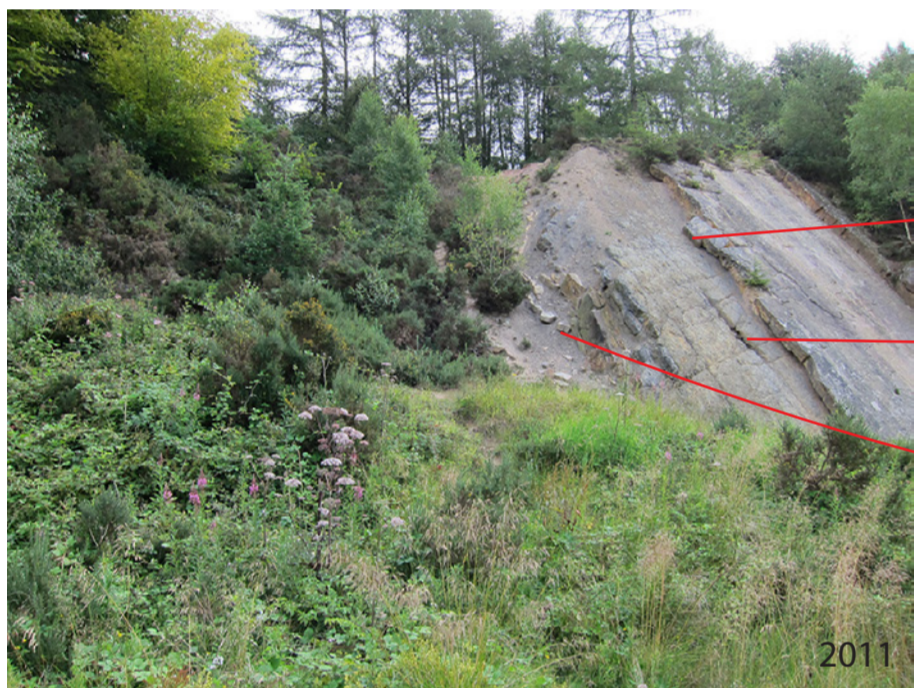
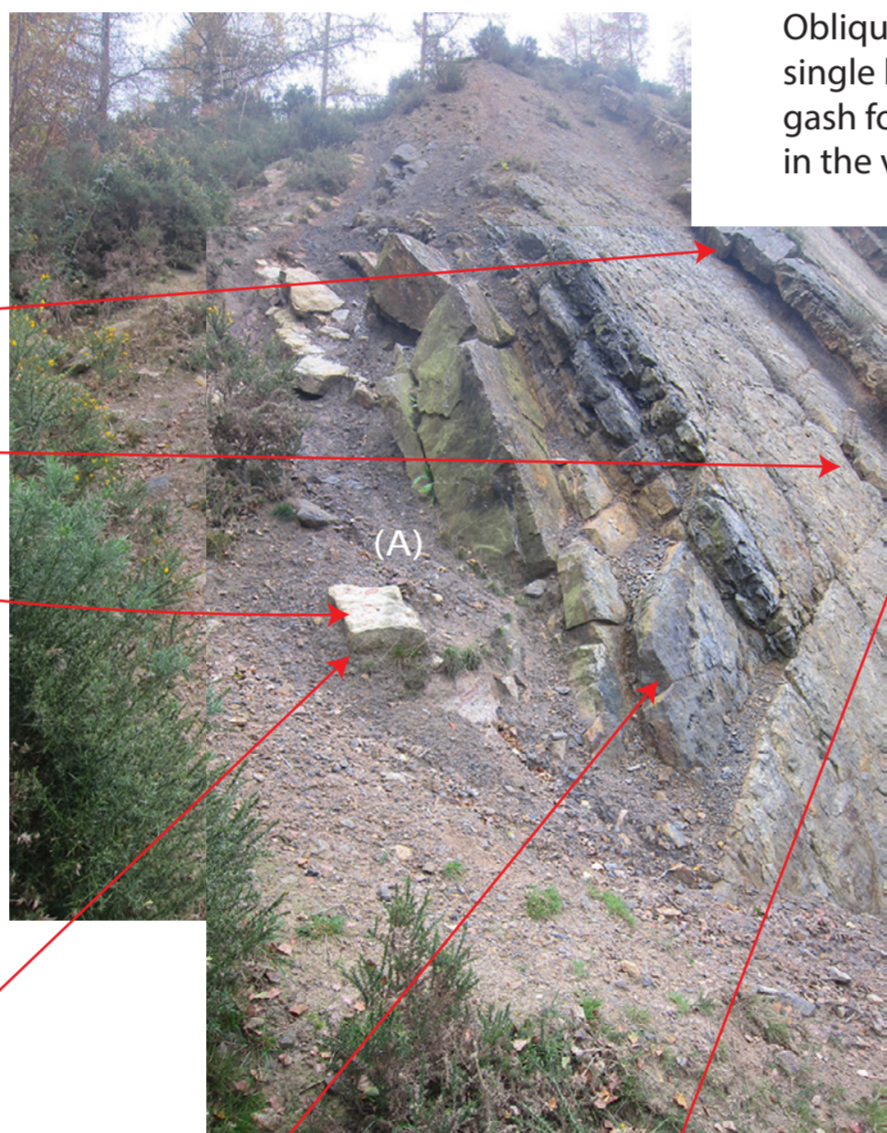
The sandstone/siltstone unit forming the southern-most part of the main face is less resilient than the rest of the face and shows some signs of damage. The damage is not significant at present, and it is not possible to determine its cause. Neither is it known whether this face is being used for climbing.

Oblique view of southern part of face. Very little obvious change over 10 years apart from a single block (A) that has been displaced. There appears to have been very little change in the gash following the joint in the near face. Neither does there appear to be any significant increase in the volume of talus at the base of the face.

1. Monitoring of the face every five years using fixed point imagery.
2. Indicate to the BMC that there are concerns about this part of the face and that its condition will be monitored.
3. If the monitoring produces clear evidence that climbing is damaging the interest features on this face, then bring in a ban on climbing in this area of the site.

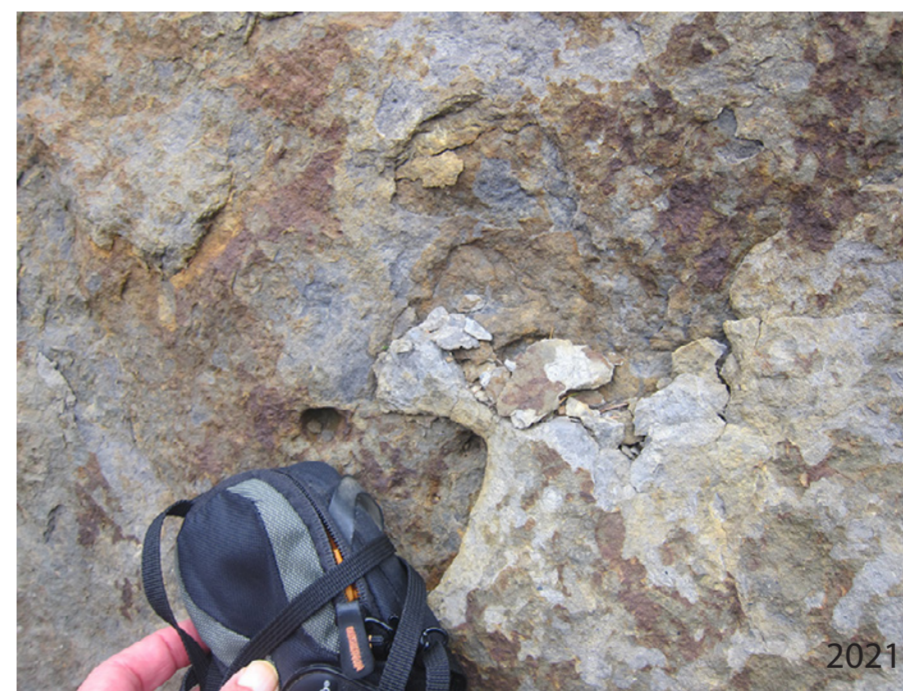
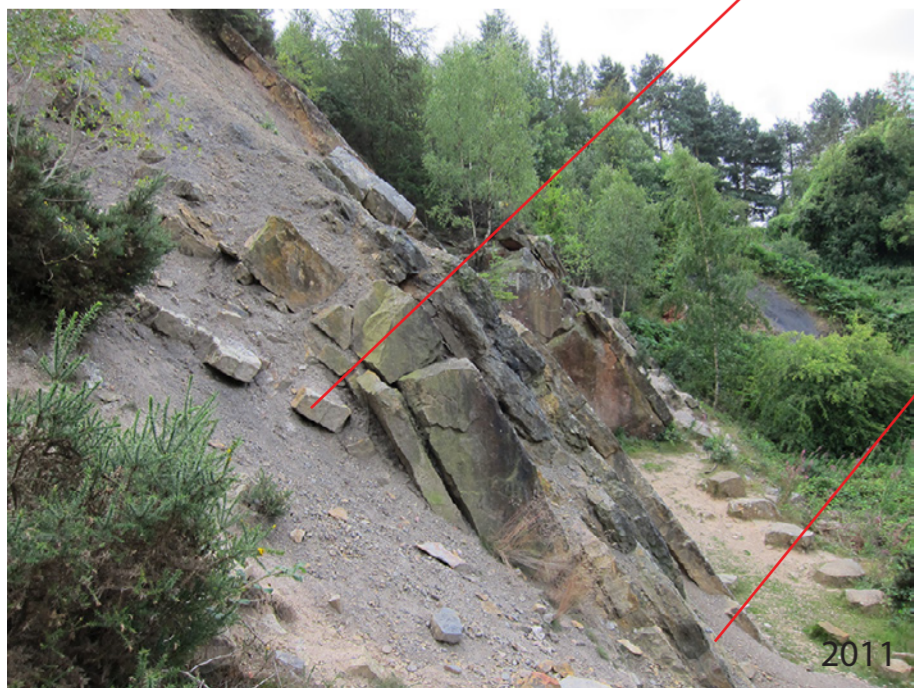
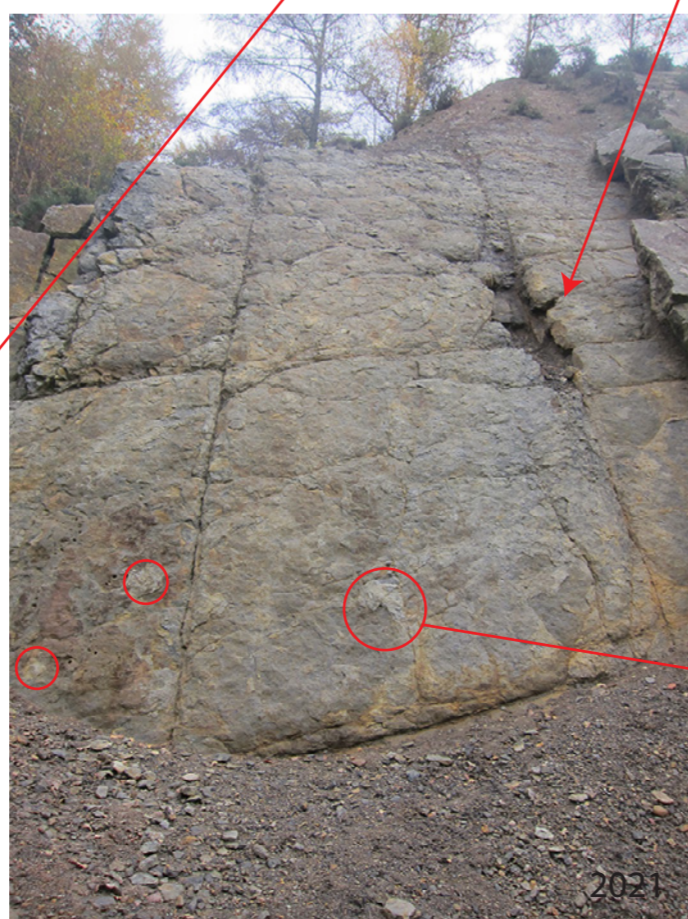
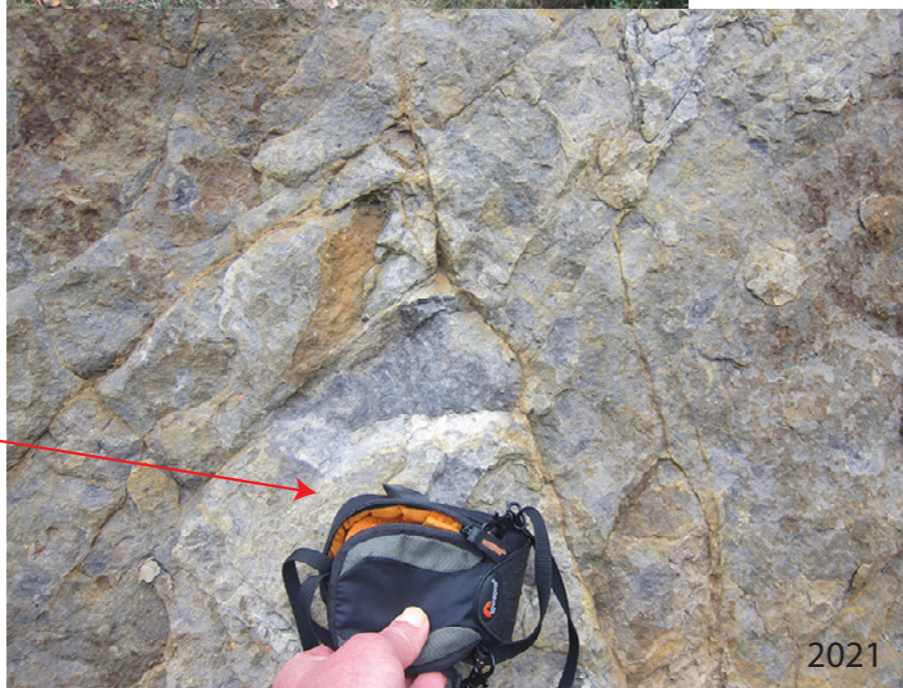
The sandstones/siltstones forming the most southerly part of the main face (underlying the hard sandstone sheet) are relatively soft and fissile, containing many small anastomosing joints. This means that the rock is relatively susceptible to weathering and damage from other sources. There are several patches near the base of the face that represent freshly broken surfaces, the cause of which is not clear, but might have been caused by footfall on the face. The bed itself contains a trace fossil assemblage (the cause of the mottling) and is an important component of the interest feature.
